WL-TR-91-4032
DOT/FAA/CT-91/23
VOL II, Part 2

COMPOSITE FAILURE ANALYSIS HANDBOOK
VOL II - TECHNICAL HANDBOOK
PART 2 - ATLAS OF FRACTOGRAPHS

R.J. Kar
Northrop Corporation
One Northrop Avenue
Hawthorne, California 90250-3277

February 1992

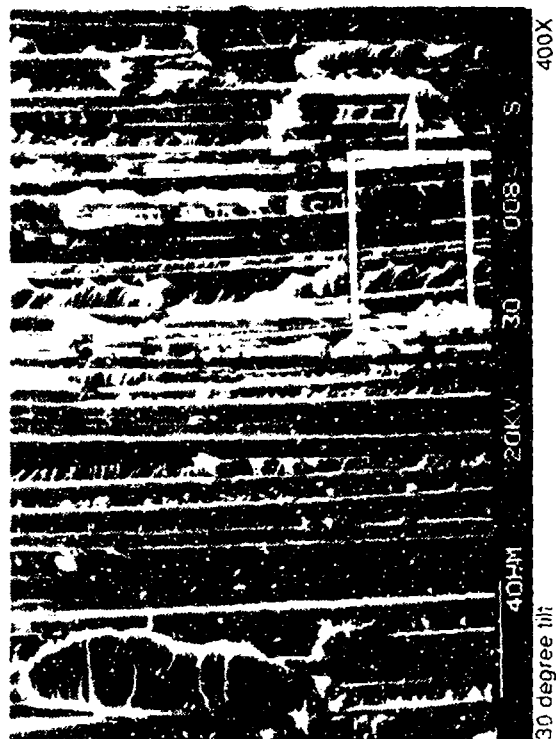
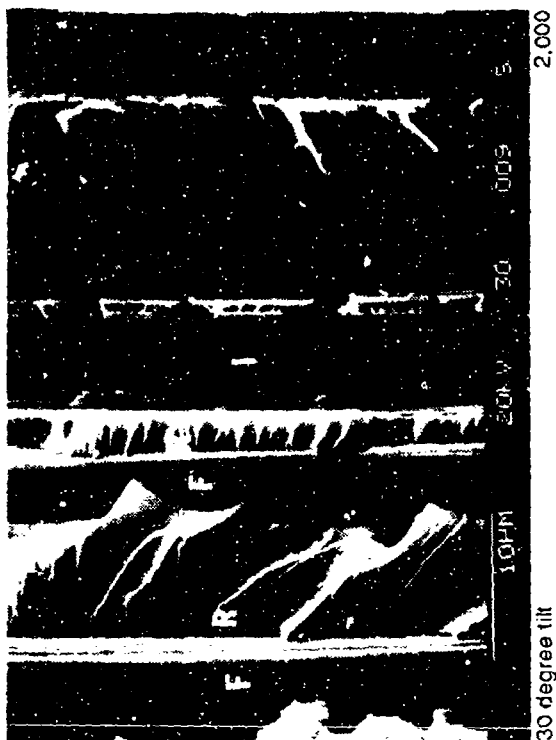
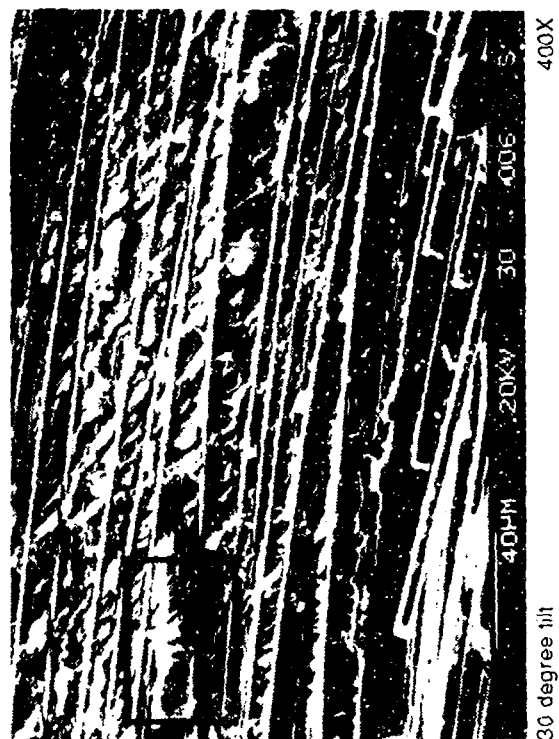
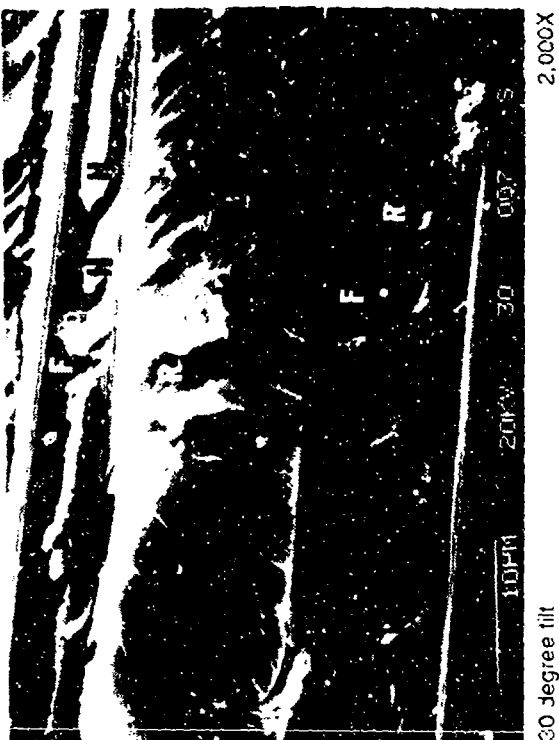
Mechanically induced crack direction

Legend: F fiber; H hackle; I fiber imprint; R rivermarks
 Figure 8-1. SEM Fractographs of Room Temperature, Mode I Interlaminar Tension Fracture in C3K 8-HS/PMR-15

Specimens tested at room temperature (RT) exhibited a reflective interlaminar surface when examined optically. SEM fractography of tows oriented perpendicular to the mechanically induced crack propagation direction revealed river marks indicating a crack growth direction consistent with the mechanically induced crack direction (Figure 8-1). Fractures at tows oriented parallel to the mechanically induced crack propagation direction were characterized by a mixed-mode morphology with poorly formed hackles in the matrix indicating shear propagation due to the influence of fabric reinforcement. Resin-rich regions between tows exhibited river marks indicating crack propagation from one tow toward the center of the adjacent tow, regardless of the mechanically induced crack propagation direction. Fiber/matrix adhesion was poor, as most fibers were bare.

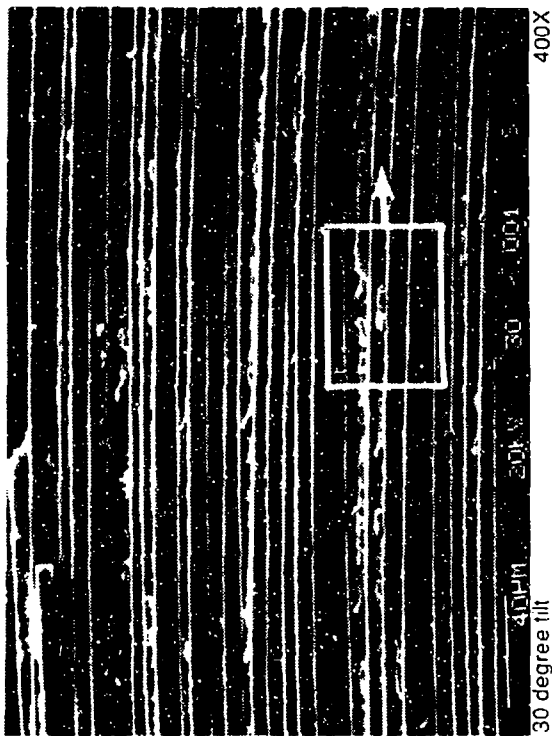
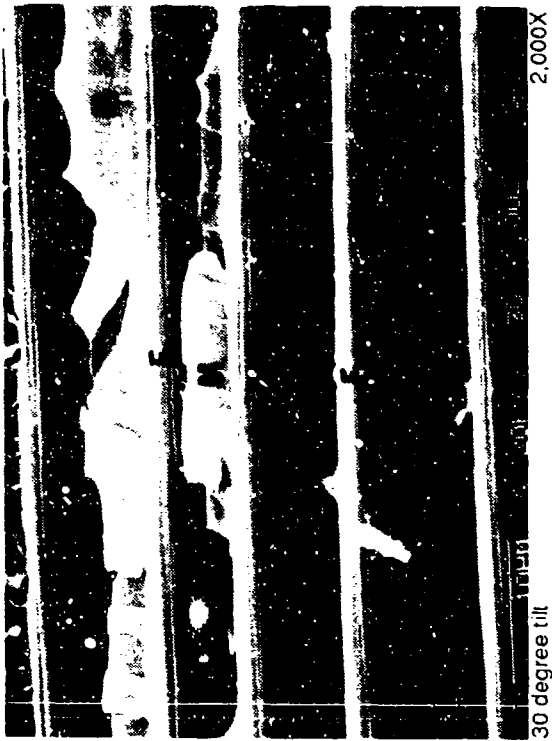
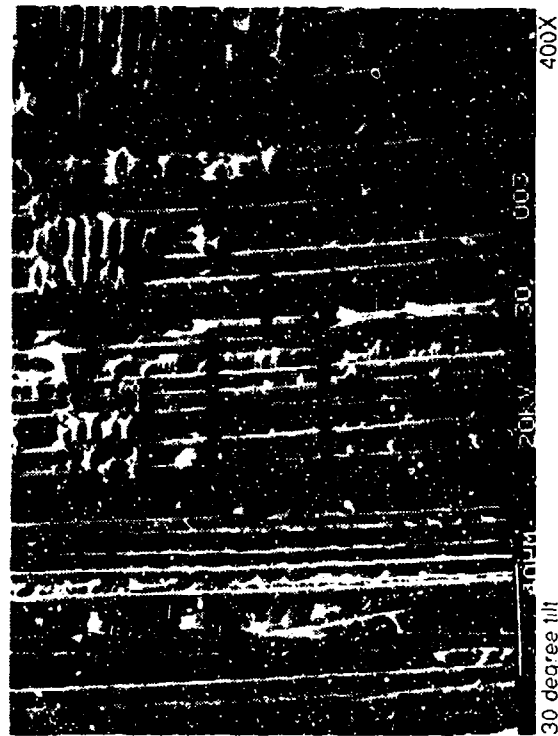
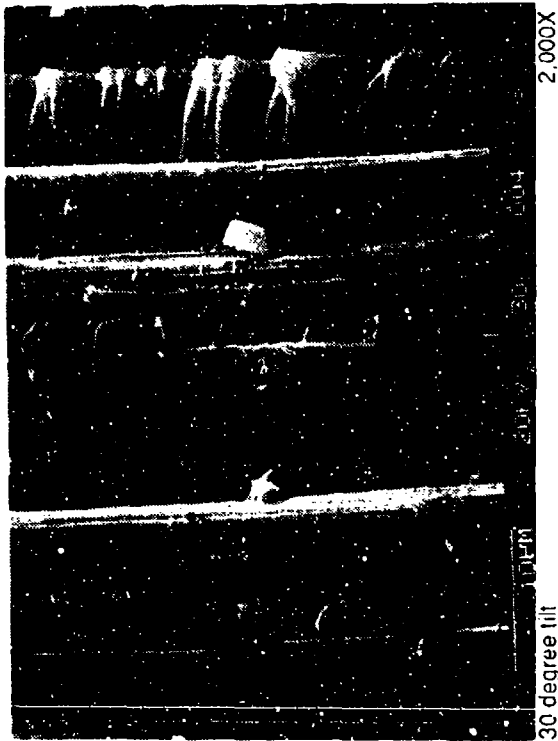
↑
Mechanically induced crack direction

Legend: F fiber; M matrix failure; R rivermarks
Figure 8-2. SEM Fractographs of 500 F/Dry, Mode I Interlaminar Tension Fracture in C3K 8-HS/PMR-15

Specimens tested at 500°F exhibited a slightly reflective interlaminar surface when examined optically. SEM fractography of tows oriented perpendicular to the mechanically induced crack propagation direction revealed river marks which indicated propagation in directions both consistent with and opposite to the overall propagation direction (Figure 8-2). Fractures at tows oriented parallel to the mechanically induced crack propagation direction were characterized by featureless matrix fracture having the appearance of shear failure. Fiber/matrix adhesion was good.

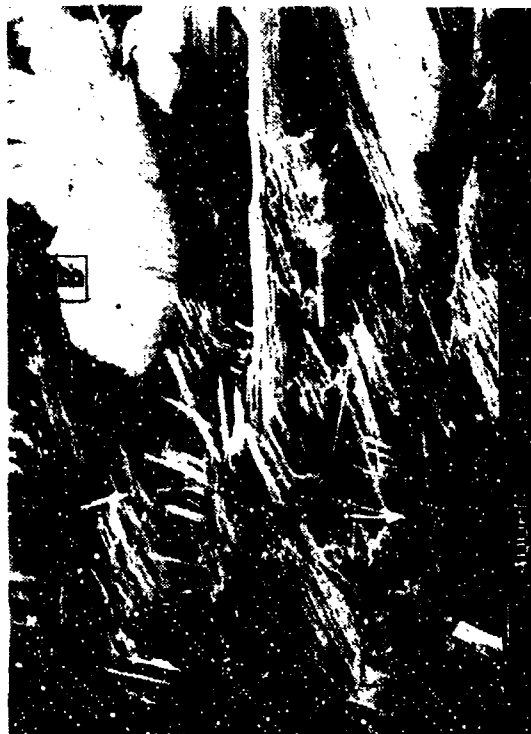
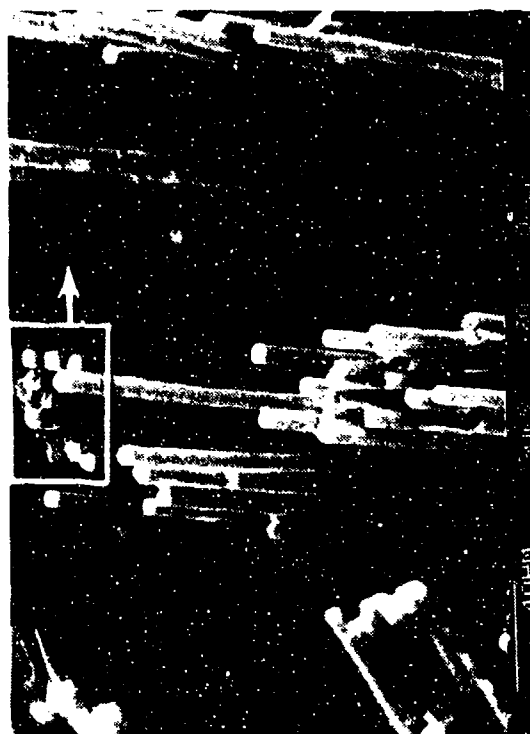
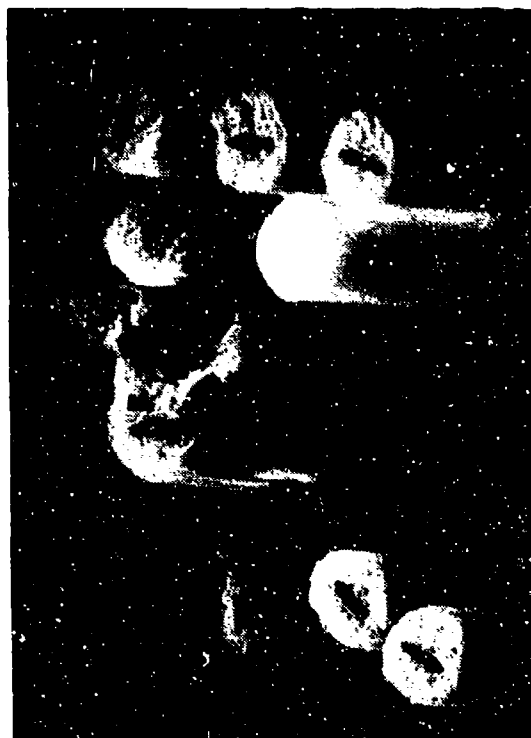
30 degree tilt 20X

30 degree tilt 400X

- F fiber fracture
- M matrix fracture

30 degree tilt 2,000X

Figure 8-5. SEM Fractographs of Room Temperature/Dry, Translaminar Tension Fracture in C3K 8-HS/PMR-15

Specimens tested at RT appeared predominantly rough and jagged due to protruding ± 45 degree fibers when examined optically, and this appearance is typical of translaminar tensile fracture. SEM fractography of the tensile portion of the fracture surface revealed fiber end features with fan patterns showing an overall propagation direction consistent with the mechanically induced crack growth direction (Figure 8-5). River marks and resin microflow in the resin-rich areas of the tensile zone also indicated a crack growth direction consistent with the mechanically induced crack growth direction.

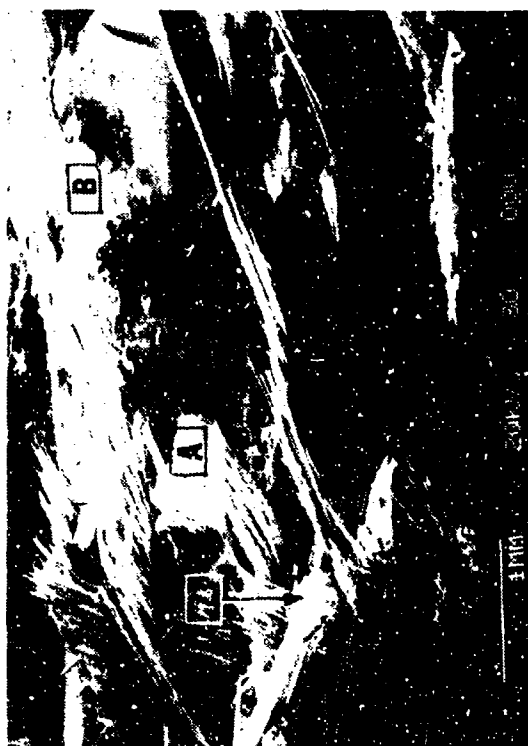
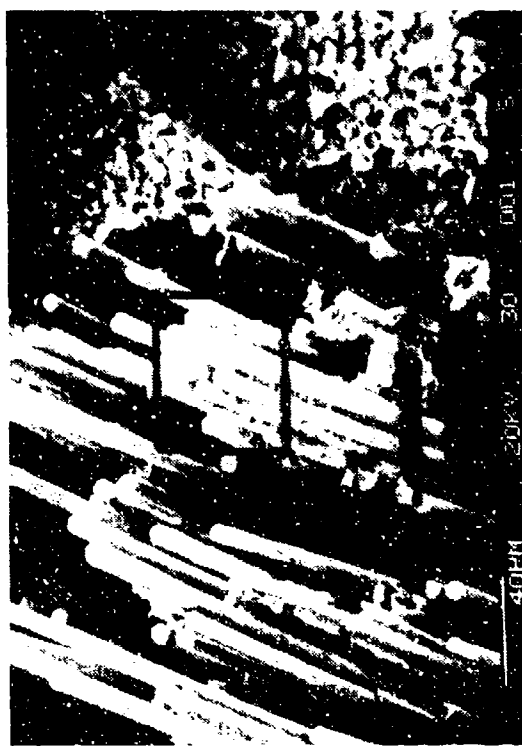
30 degree tilt 20X

30 degree tilt 400X

30 degree tilt 2,000X

Figure 8-6. SEM Fractographs of 500 F/Dry, Translaminar Tension Fracture in C3K 8-HS/PMR-15

Specimens tested at 500°F exhibited rough translaminar tensile characteristics over a quarter of the surface when examined optically, and the remainder of the surface appeared compressive. SEM fractography of the tensile region revealed small bundles of fibers on the fracture plane, due to fiber pullout (Figure 8-6). Radial patterns found on fiber end fractures indicated a crack growth direction consistent with the mechanically induced crack growth direction. Microbuckling and typical compressive fiber end fractures were observed on the compressive portion of the fracture surface. Fiber/matrix adhesion was fair.

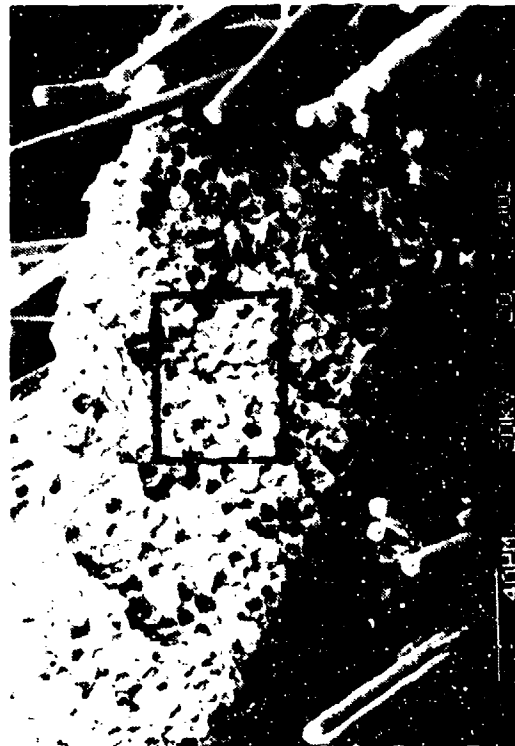
20 degree tilt 20X

20 degree tilt 400X

C compression
N neutral axis
T tension

20 degree tilt 2,000X

Figure 8-7. SEM Fractographs of Room Temperature/Dry, Translaminar Compression Fracture in C3K 8-HS/PMR-15

Optical examination of specimens tested at RT revealed both tensile and compressive regions, as was found on the translaminar tension specimens (Figure 8-7). The compressive zone in this specimen was approximately a third of the fracture surface with the remainder being tensile. The compressive loading appeared to have initiated a tensile crack on the opposite edge surface which propagated toward the notch and intersected the compressive damage. SEM examination of the tensile portion revealed fiber end fractures that indicated propagation toward the compressive zone. The compressive region revealed a debris-covered surface with fiber end fractures containing both tensile and compressive zones. Resin-rich fractures in the tensile zone

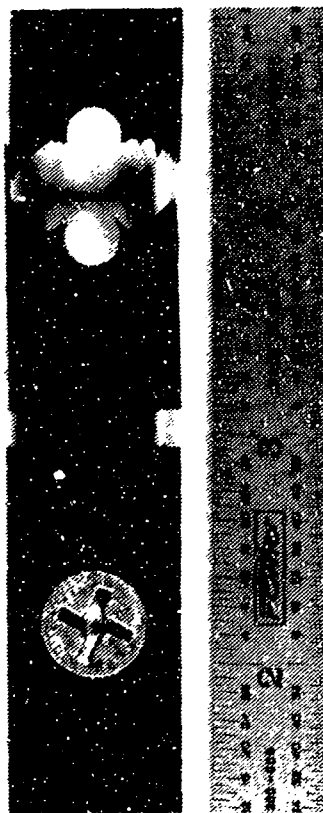
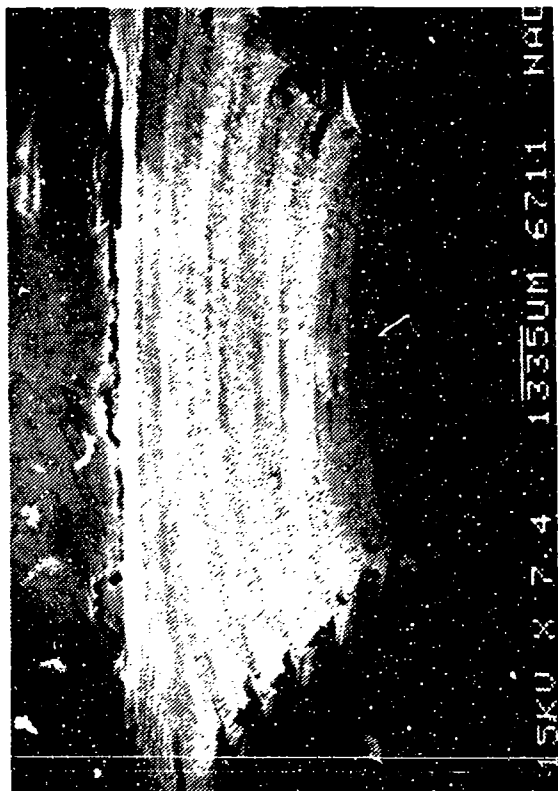
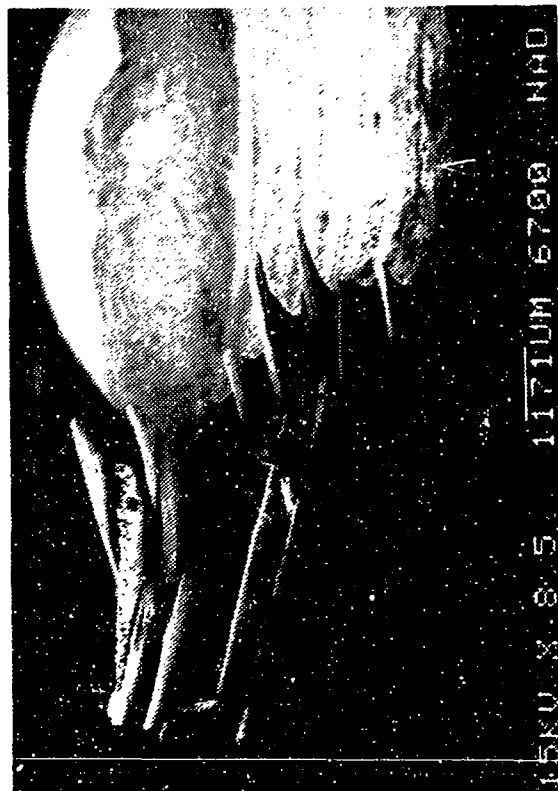
Figure 9-1. Optical and SEM Photographs of Tension Failure in a AS4/3501-6 Gr/Ep Bolted Joint

(a) Macro photograph of Failed Joint

(b), (c) Macro photographs of Failed Adherends

Note compression damage (arrows)

Fractographic evaluation of the bolted Gr/Ep joints indicates that varying failure modes occur in these specimens, and examination of individual plies can be used to establish the failure trends in these joined structures. The fractographs relating to bolted joints are provided in Figures 9-1 through 9-6. This contribution was made by Northrop.

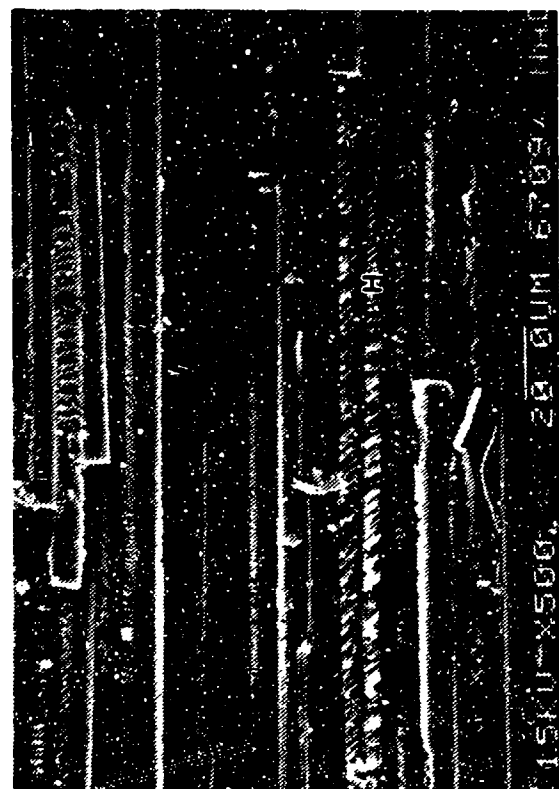
(d)

Figure 9-1. (Continued)
(d), (e) Hackles (H) in 90 and 45 Degree Plies
(f) DAF Radials on 0 Degree Fibers

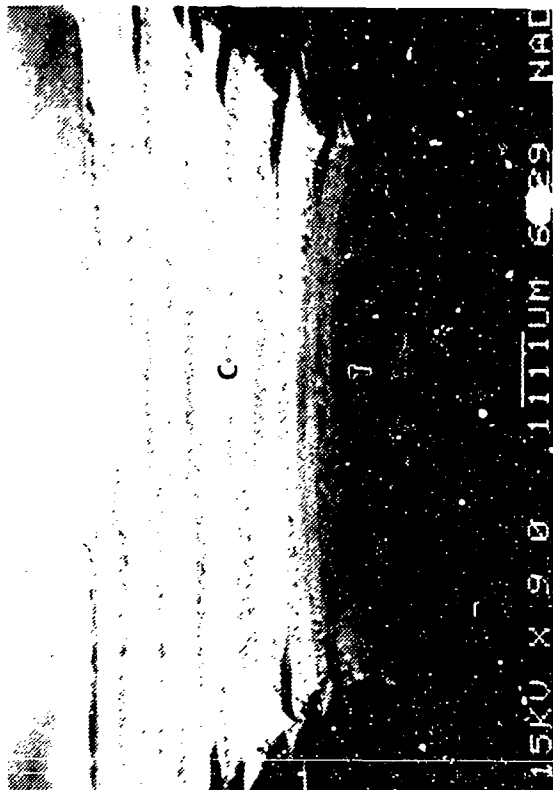
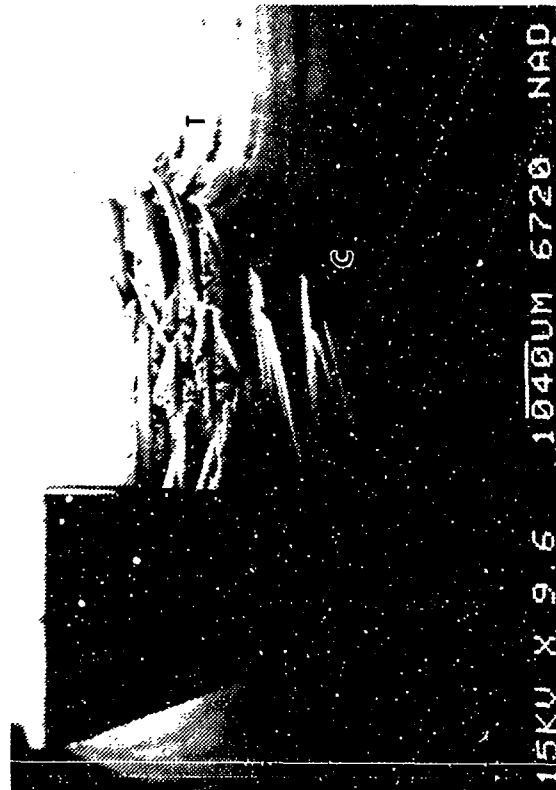
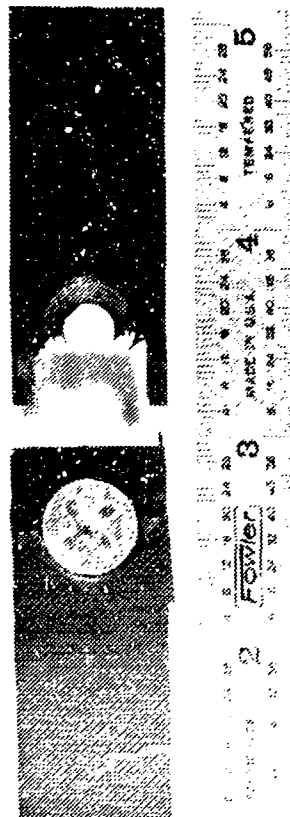
Figure 9-2. Optical and SEM Photographs of Tension-Cleavage Failure in a AS4/3501-6 Gr/Ep Bolted Joint
(a) Macro photograph of Joint
(b), (c) Macro photographs of Peripheral Regions of Bolt-Hole in Mating Halves

C = Compression failure
T = Tension failure

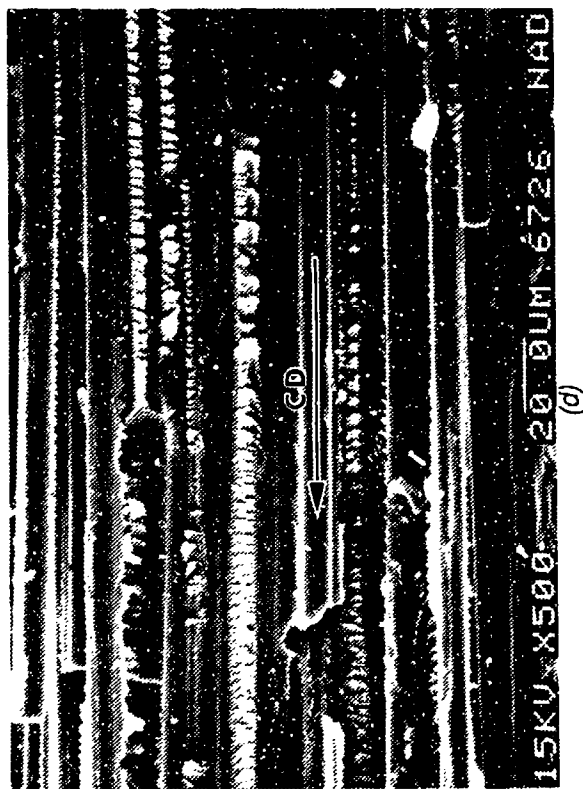
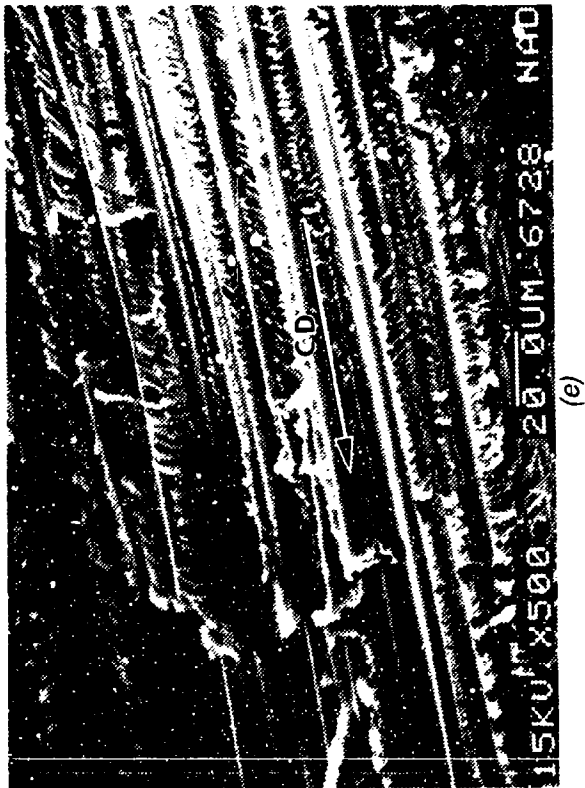
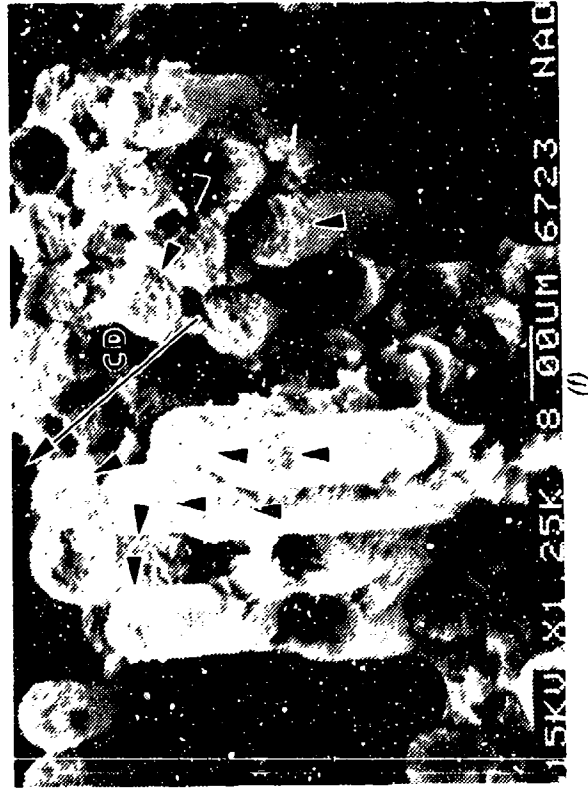
Figure 9-2. (Continued)
(d) Transaminar Fracture in 90 Degree Ply in Tensile Fracture Region

(e) Fracture in 45 Degree Ply

(f) Tensile Fracture in 0 Degree Ply
Note DAF radials (arrows)

CD = Crack propagation direction

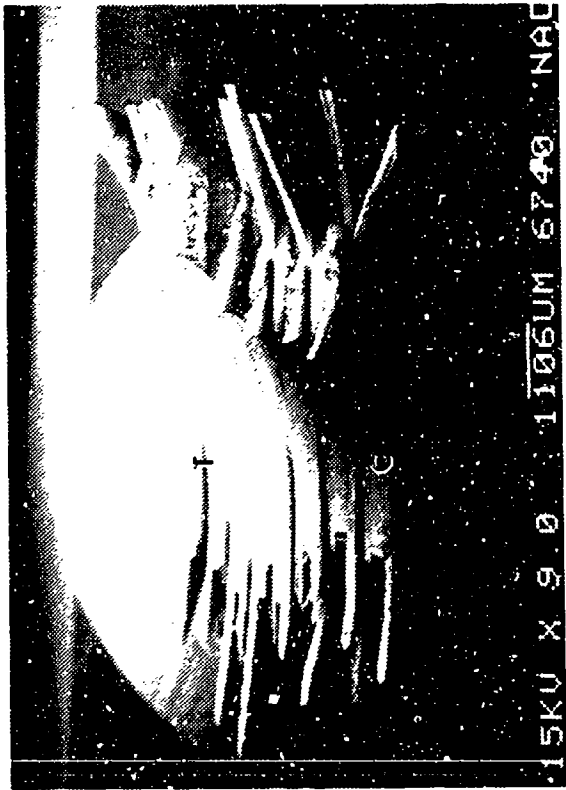
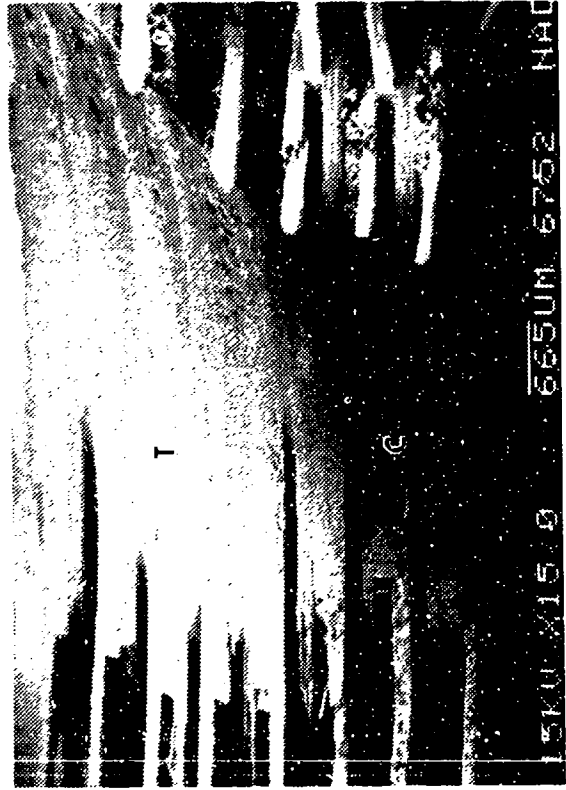
Figure 9-3. Optical and SEM Photographs of Shear-Out Failure in a AS4/3501-6 Gr/Ep Bolted Joint

(a) Macro photograph of Failed Joint
(b), (c) Macro photographs of Failed Adherends

Note compression (C) and tension (T) regions

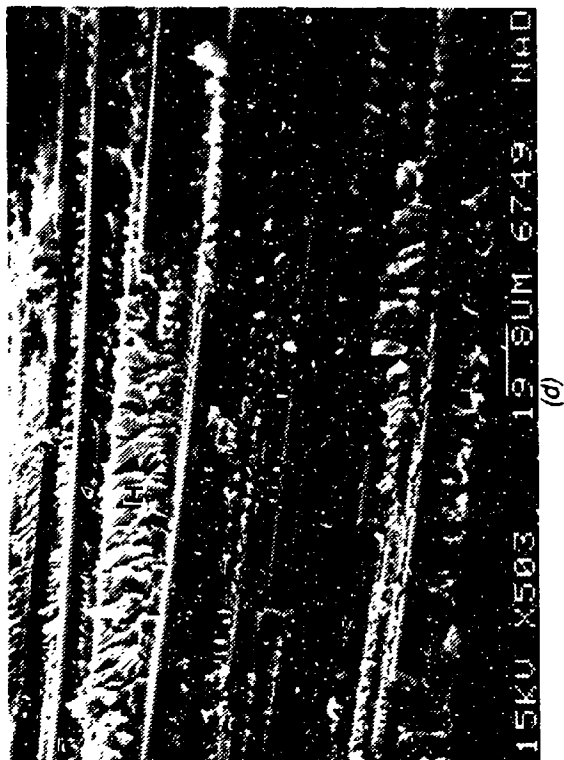
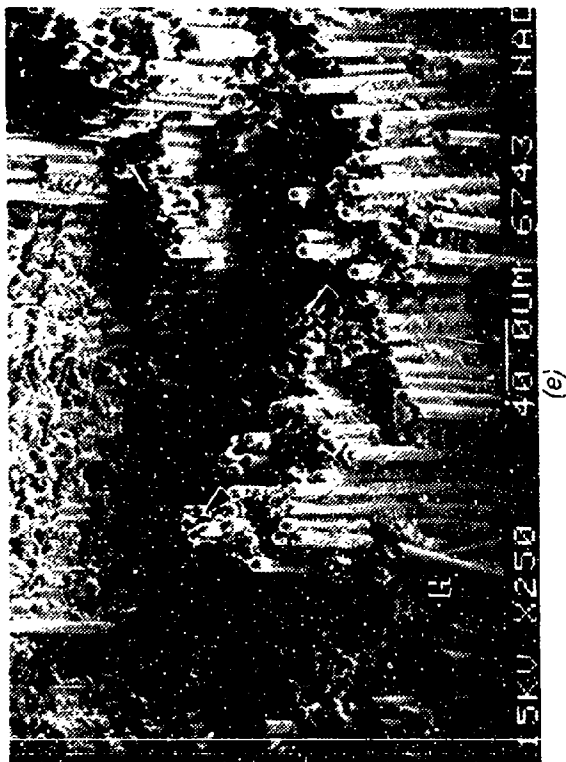
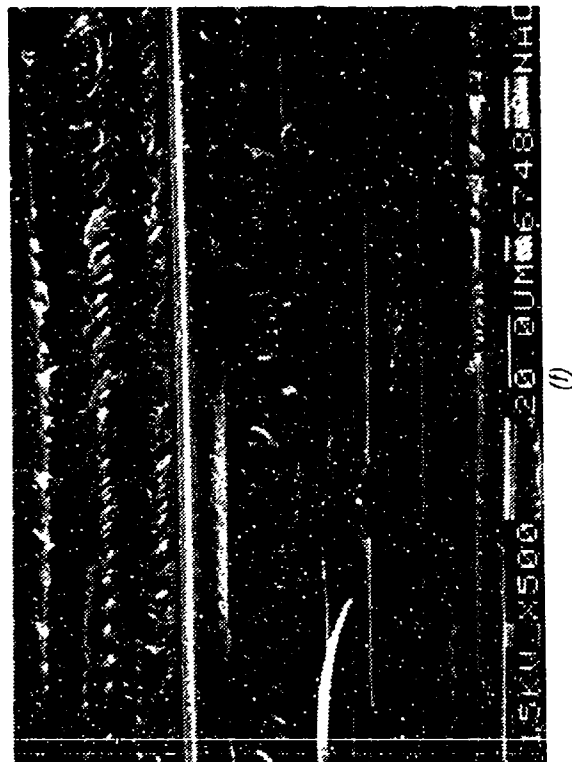
Figure 9-3. (Continued)
 (d) Hackles (H) in 45 Degree Plies
 (e) DAF Radials (Arrows) and Hackles (H) in
 0 Degree Plies
 (f) Peel Characteristics in 90 Degree Plies

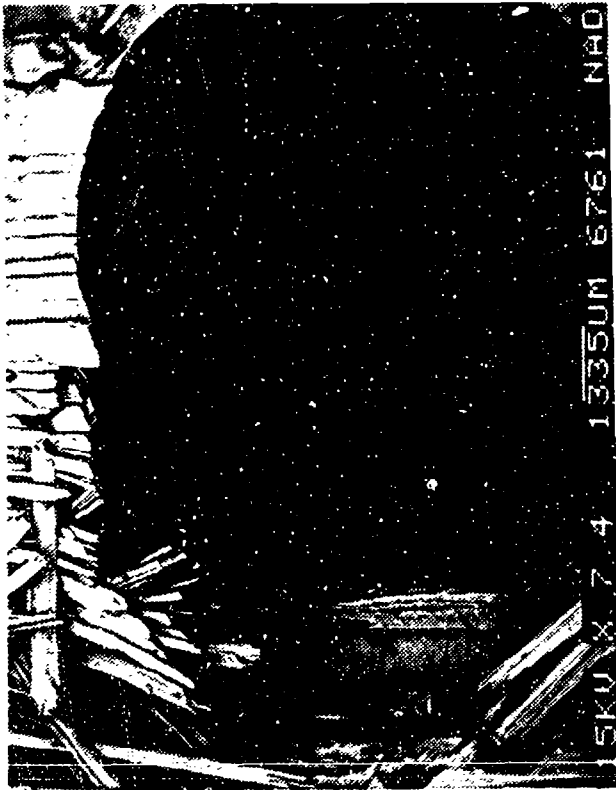
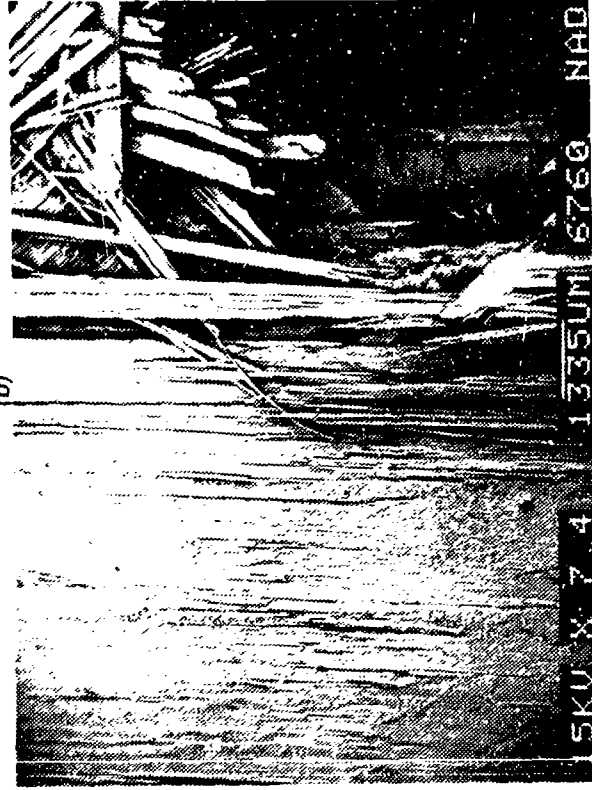
Figure 9-4. Optical and SEM Photographs of Bearing Failure
in a AS4/3501-6 Gr/Ep Bolted Joint
(a) Macro photograph of Failed Joint
(b) Detail Near Bolt-Hole
(c) Fractured Adherends

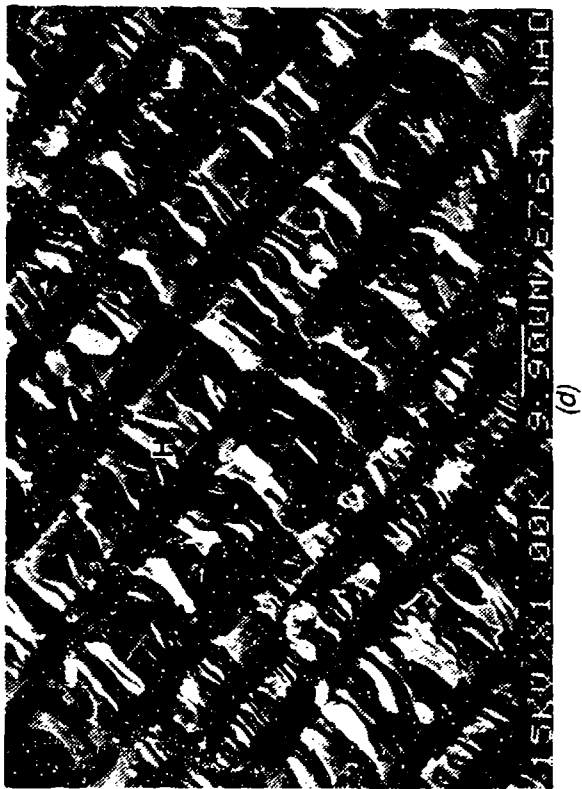
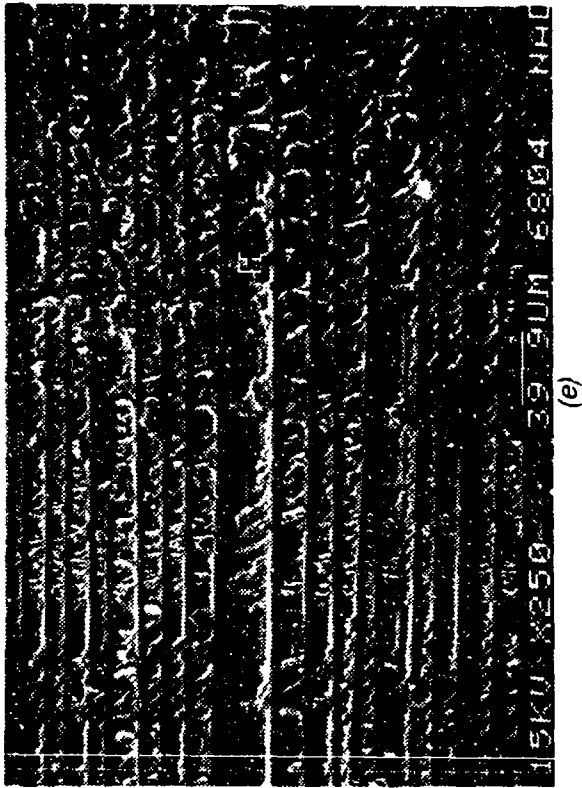
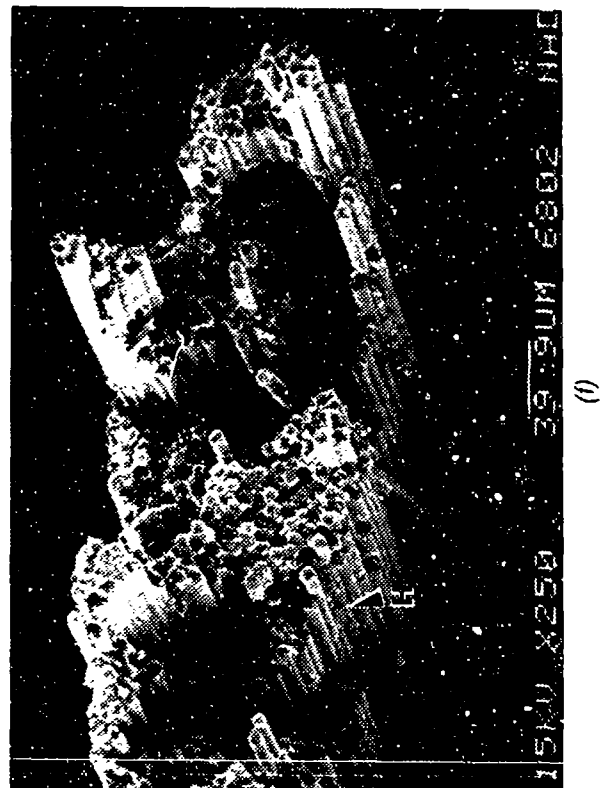
Figure 9-4. (Continued)
(d), (e), (f) Hackles (H) in 45, 90, and 0 Degree Plies

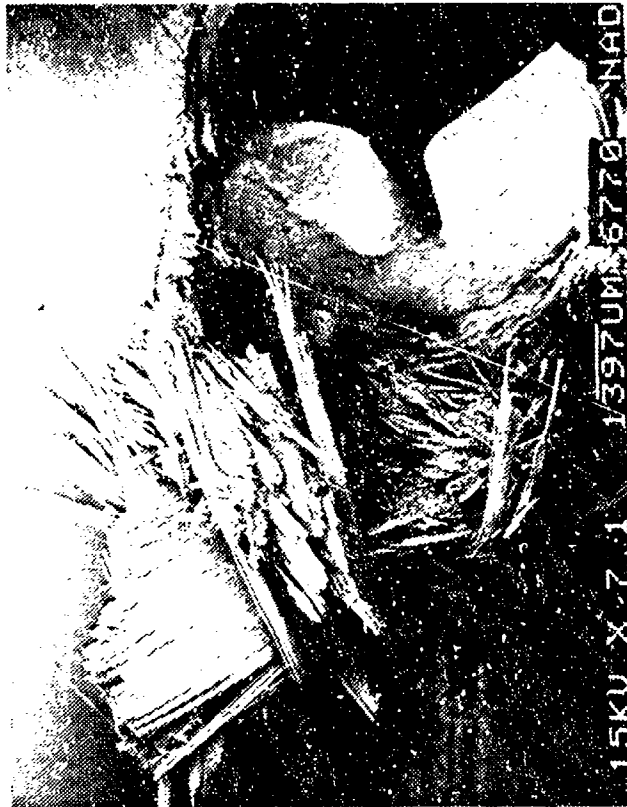
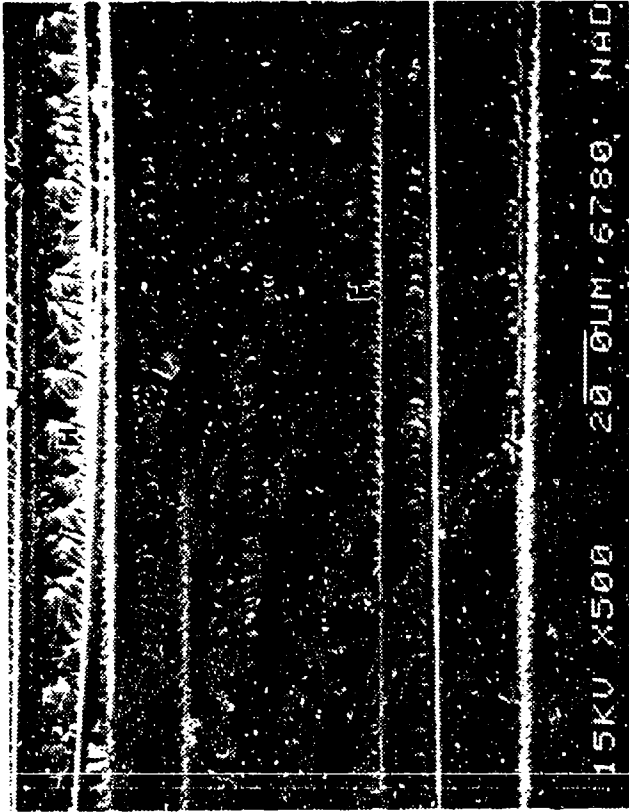
Figure 9-5. (Continued)
 (c) Fracture Detail in Fiber Crush Region
 (d) Shear Fracture in Delamination Region
 Note hackles (H)

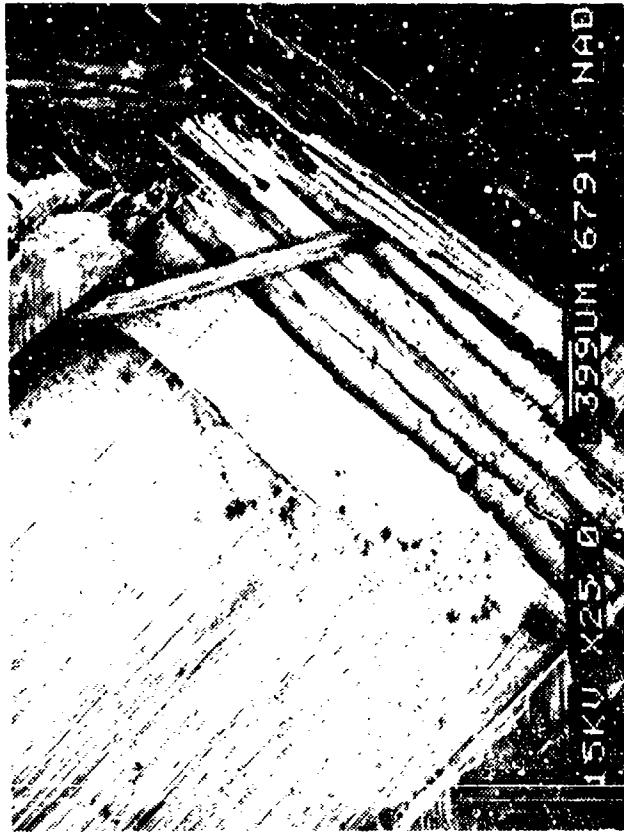
Figure 9-6. Optical and SEM Photographs of Bolt Failure in a AS4/3501-6 Gr/Ep Bolted Joint
 (a) Macro photograph Showing Delamination in Adherend (Arrow)
 (b) Peel Fracture in Surface Delamination (Low Magnification)

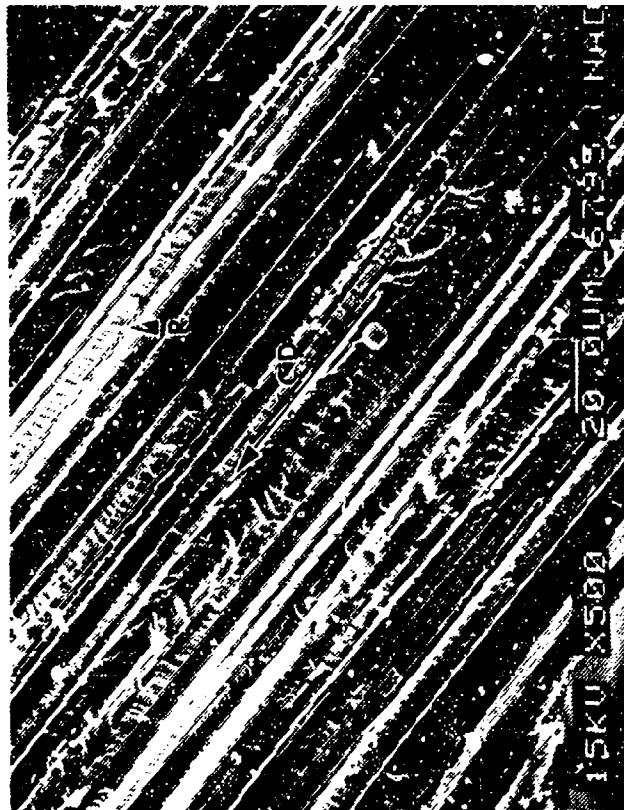
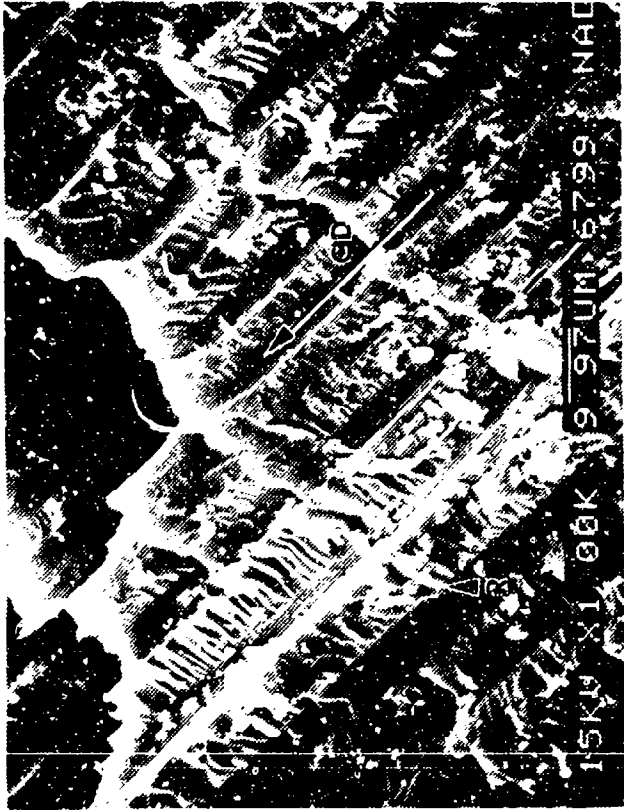
Figure 9-6. (Continued)
 (c) Peel Fracture in Surface Delamination (Intermediate Magnification)
 (d) Peel Fracture in an Internal Delamination

Note arrays of rivers (R) oriented along CD
 CD = Crack propagation direction

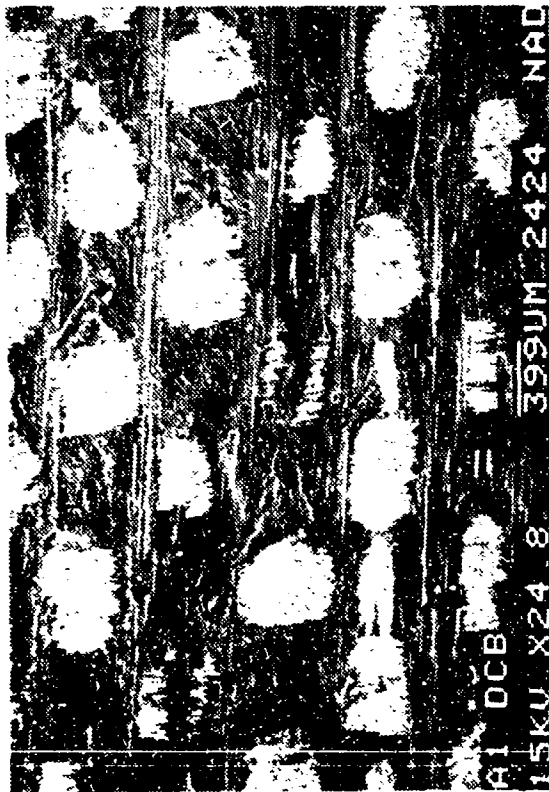
Failure in unidirectional AS4/3501-6 GFR/Ep adherends bonded with FM 300 adhesive and tested under interlaminar Mode I tension. The image shows a dark, textured surface with a bright, irregularly shaped region labeled 'A' indicating adhesive failure. A label 'C' is also visible near the bottom center.

Figure 10-1. Optical and SEM Photographs of Failure in Unidirectional AS4/3501-6 GFR/Ep Adherends Bonded With FM 300 Adhesive and Tested Under Interlaminar Mode I Tension
(a) Macro photograph
(b) Low Magnification (4X) Photograph Showing Failure Detail
(c) Adhesive Failure Region

A = Adhesive failure
C = Cohesive failure
CD = Crack propagation direction

Fractographs relating to adhesively bonded Gr/Ep are provided in Figures 10-1 through 10-8 and those relating to adhesively bonded Gr/BMI are provided in Figures 10-9 through 10-12. This contribution was made by Northrop.

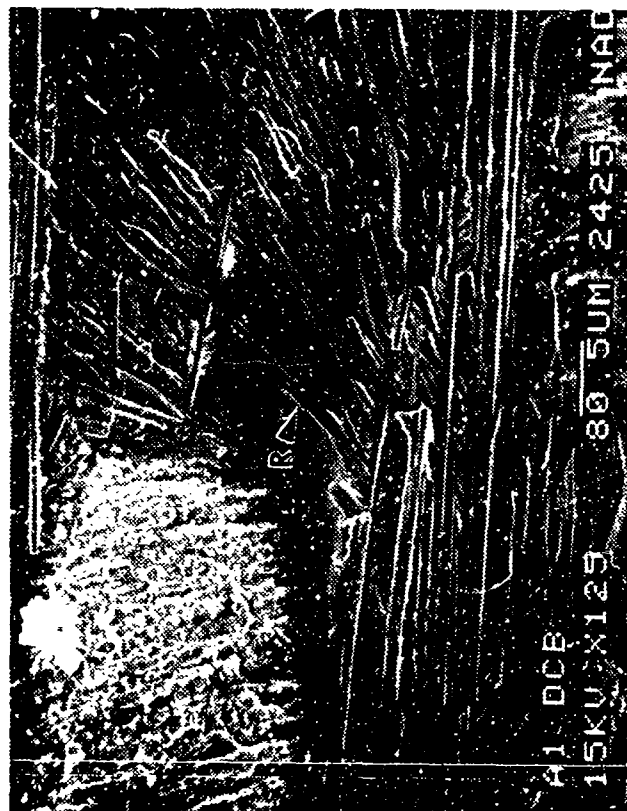
Figure 10-1. (Continued)
 (d) River Patterns (R) in Fractured Adhesive in Cohesive Failure Area
 (e) River Patterns (R) in Fractured Epoxy in Adhesive Failure Region

CD = Crack propagation direction
 S = Scrim

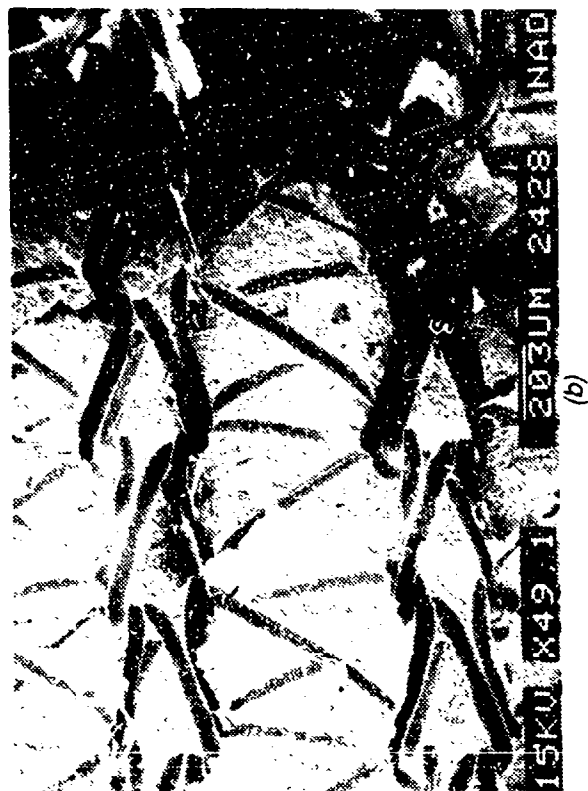
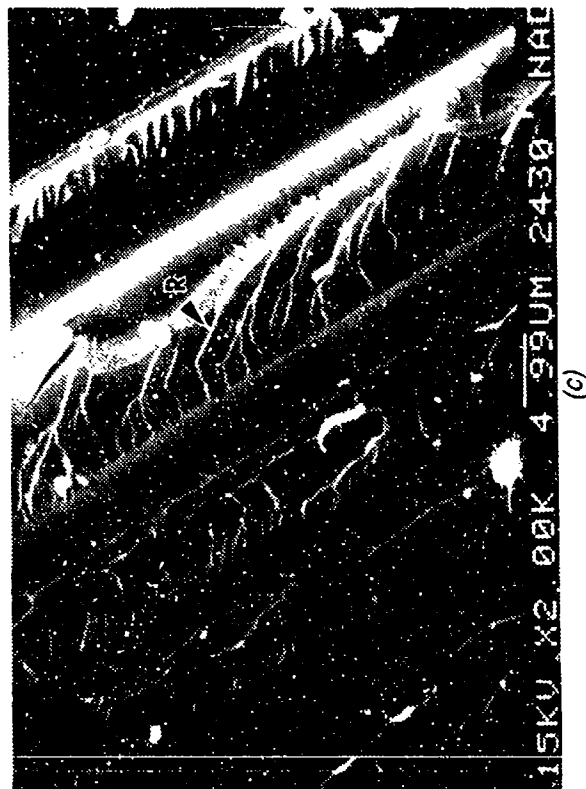
Figure 10-2. Optical and SEM Photographs of Failure in Unidirectional Gr/Ep Bonded to Quasi-Isotropic Gr/Ep With FM 300 Adhesive and Tested Under Mode I Tension

(a) Macro photograph
(b), (c) Adhesive Failure Region

A = Adhesive failure
C = Cohesive failure
CD = Crack propagation direction
R = River patterns
S = Scum

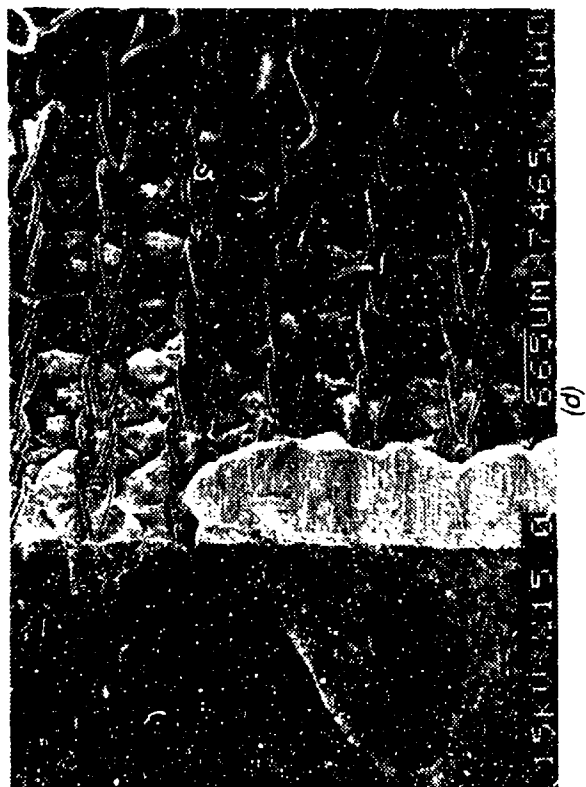
Figure 10-3. (Continued)
(d), (e) Cohesive Failure in FM 300 Adhesive
(f) Hackles (H) in Fractured Adherends in Adhesive Failure Region

CD - Crack propagation direction
S = Scram

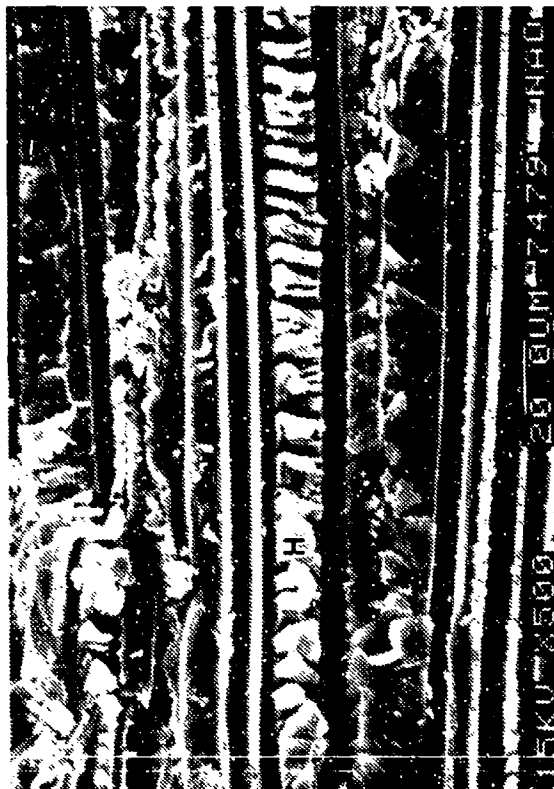
Figure 10-4. (Continued)
 (d). (e) Cohesive Failure in FM 300 Adhesive
 (f) Hackles (H) in Fractured Adherends in Adhesive Failure Region

CD = Crack-propagation direction

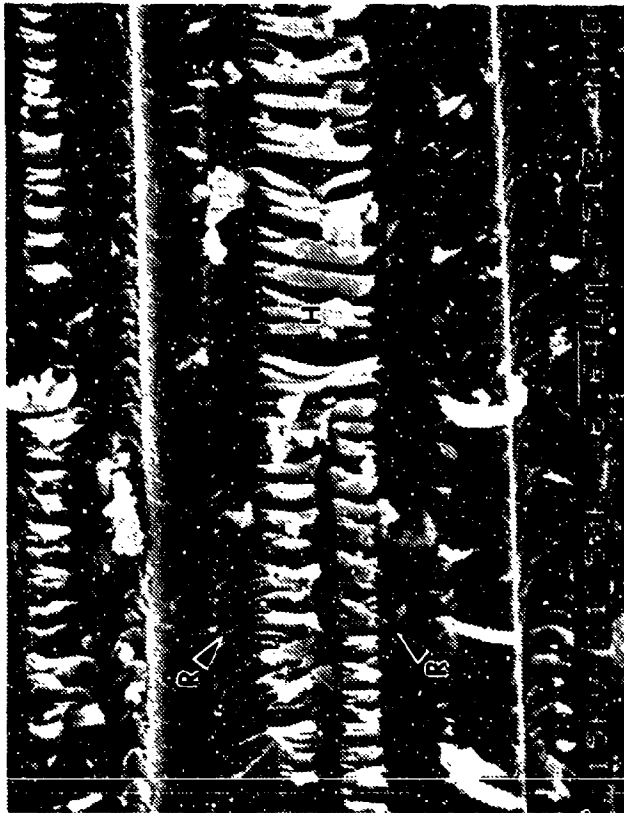
Figure 10-5. (Continued)
 (d) Hackles in 45 Degree Ply
 (e) Hackles and Rivers in 0 Degree Ply
 H = Hackles
 R = Rivers
 CD = Crack-propagation direction
